**Torfaen County Borough Council**  
**Flood and Water Management Act 2010**  
**Section 19 Flood Investigation Report-**  
**Cwmbran**

**22/05/2014**

**9/09/2014**

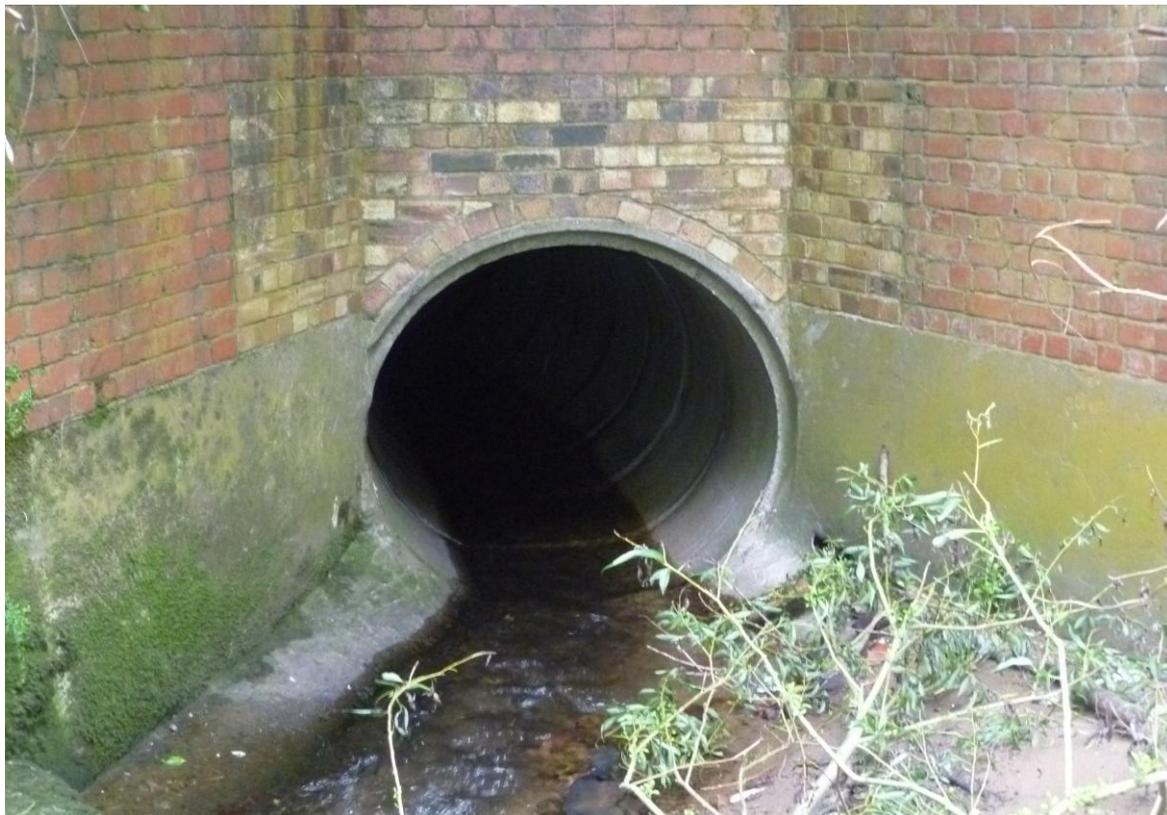
Image 1: A 1.5m Diameter culvert designed for the 1 in 100 event return period approved by the National Rivers Authority in 1992/3.

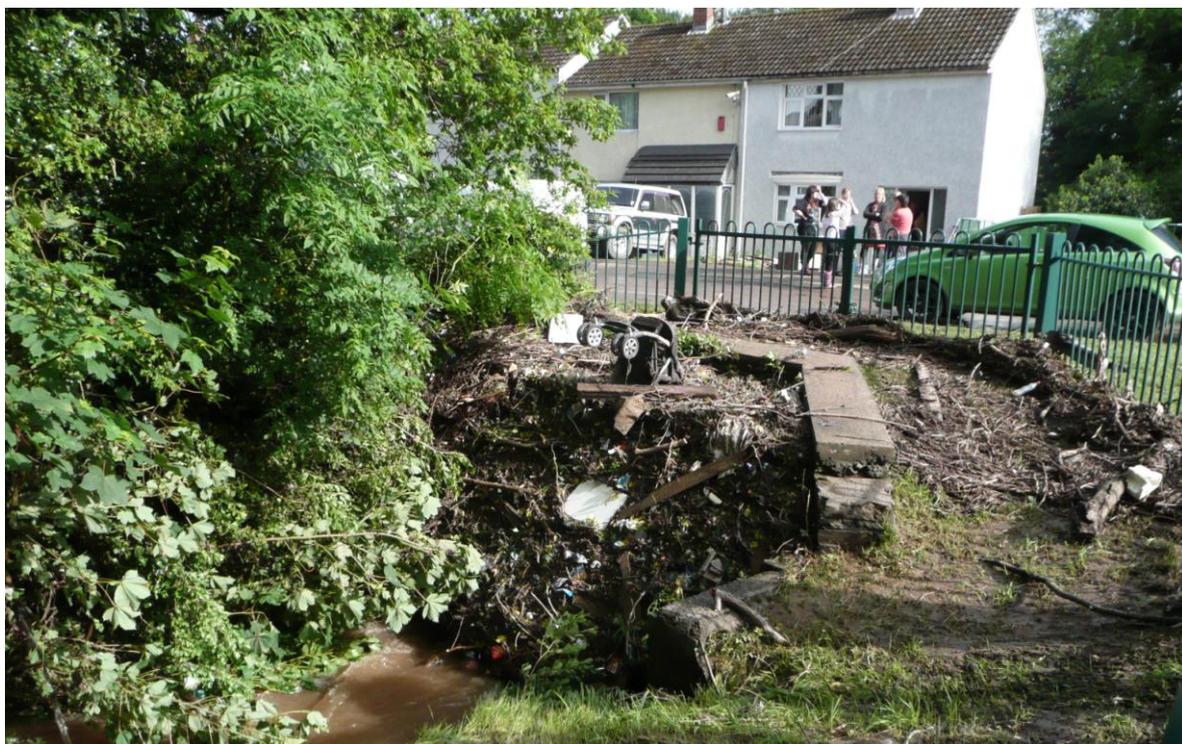
Image 3: Culvert No 96 after the flooding.

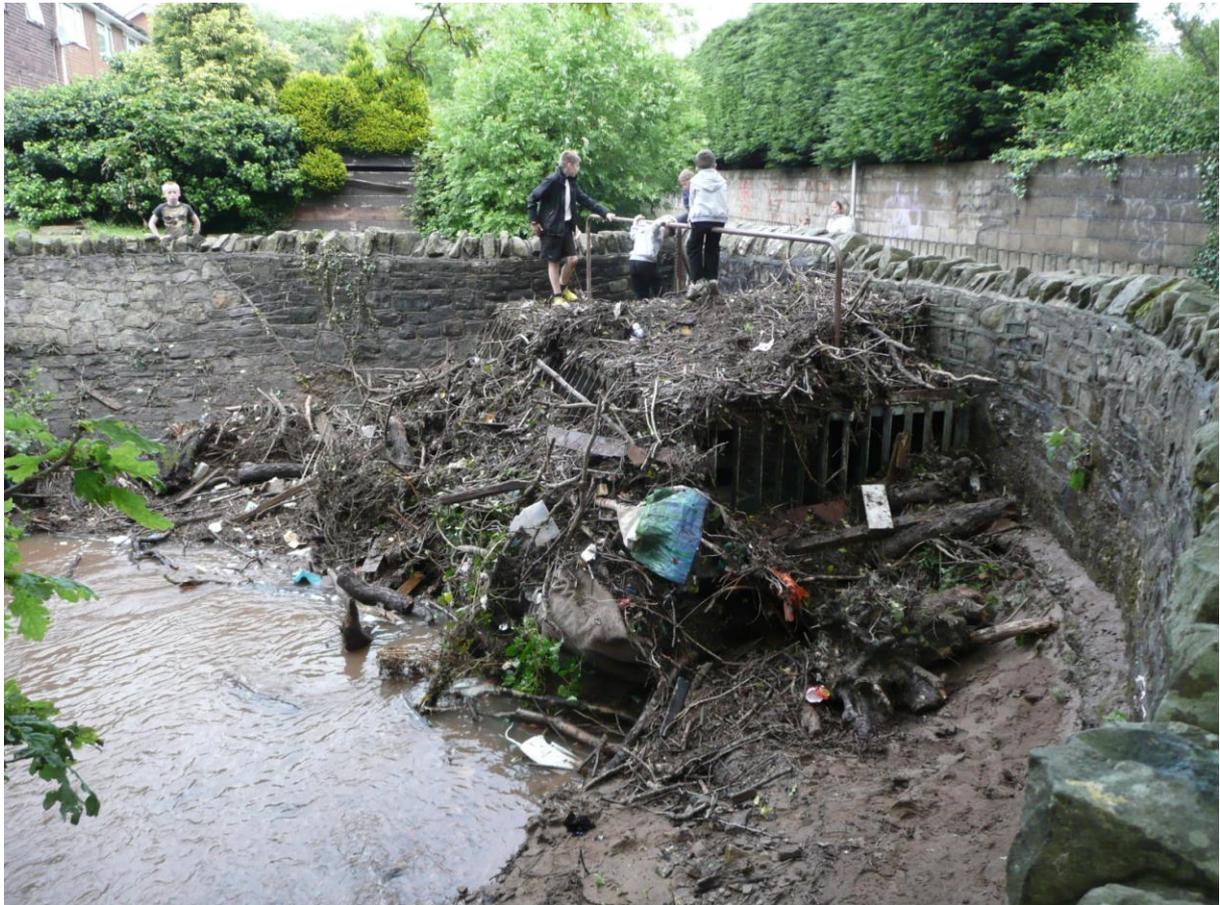
Image 4: Culvert No 95 after the flooding event

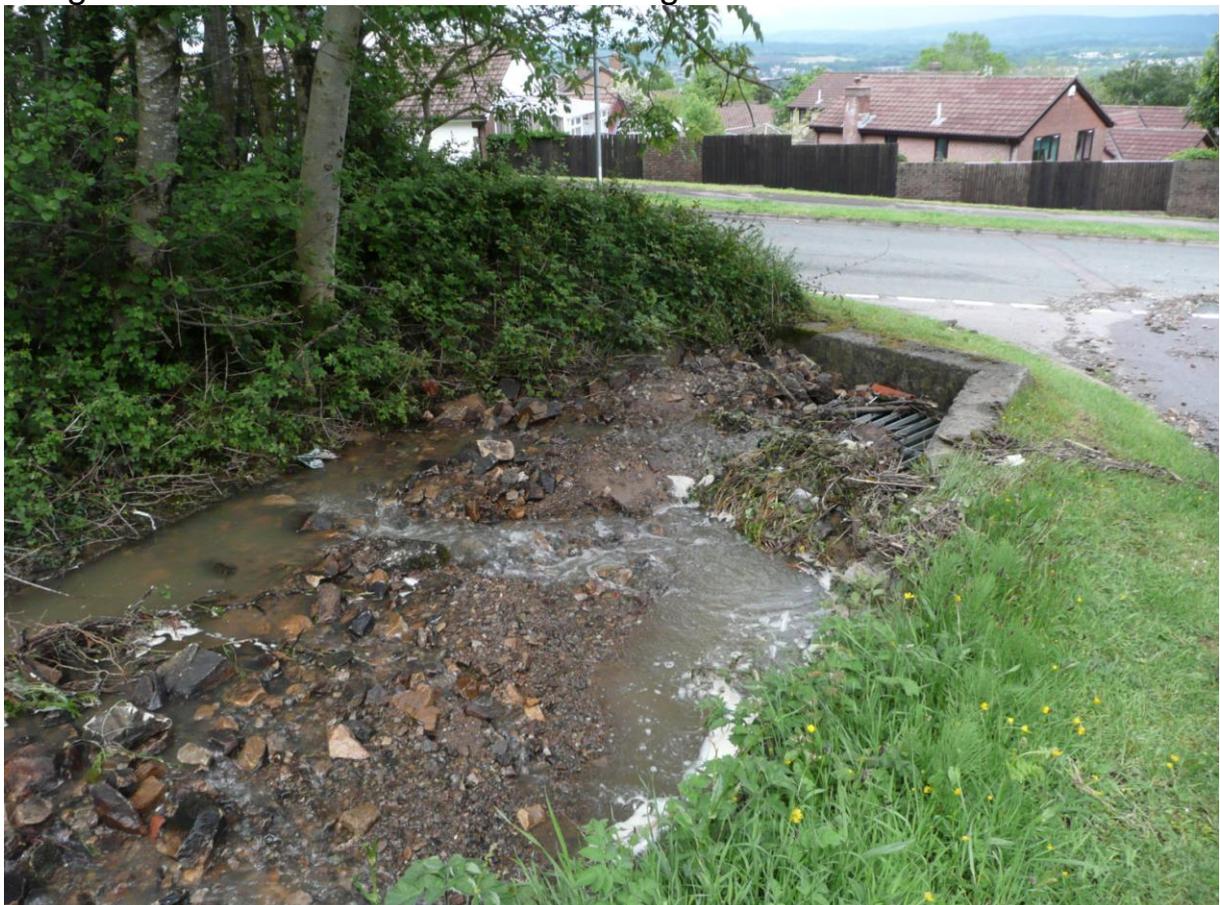
Image 5: Culvert No 134 after the flooding event

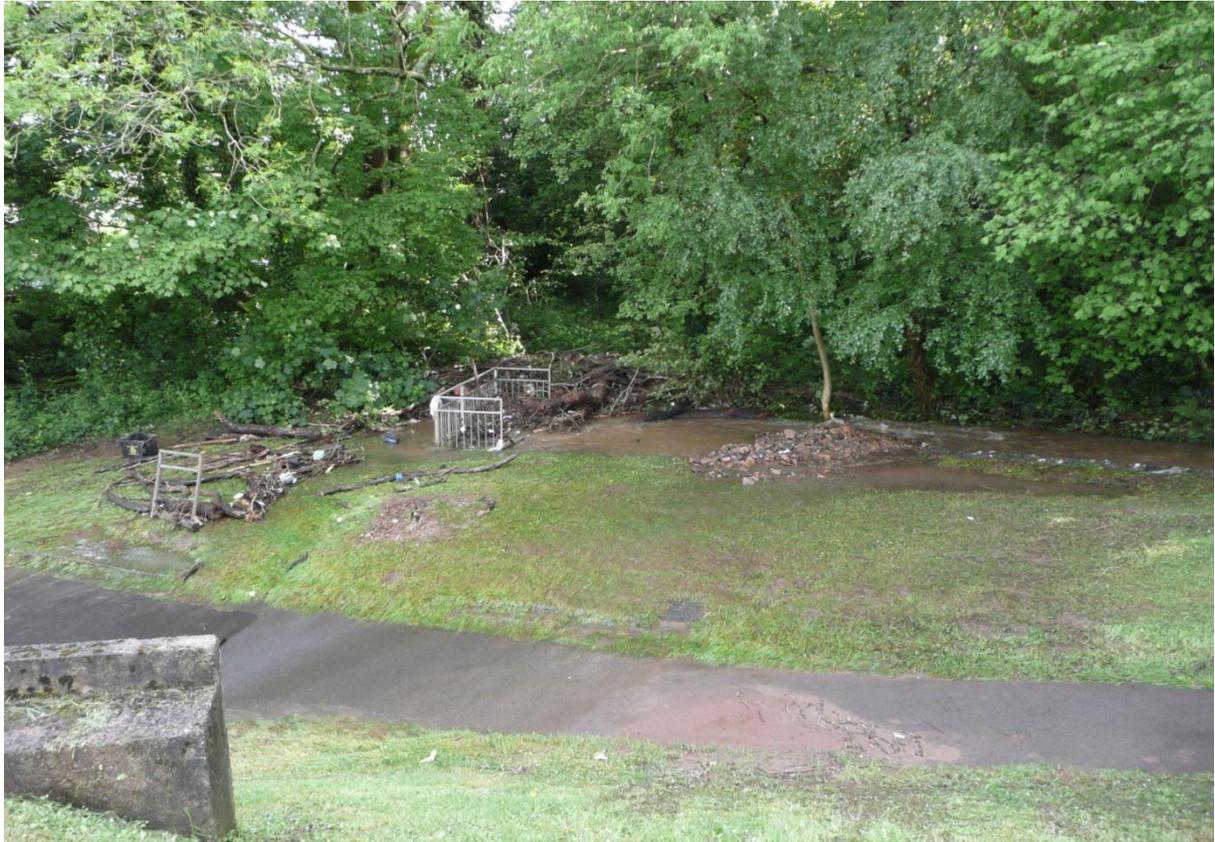
Image 6: Culvert no 94 after the flooding

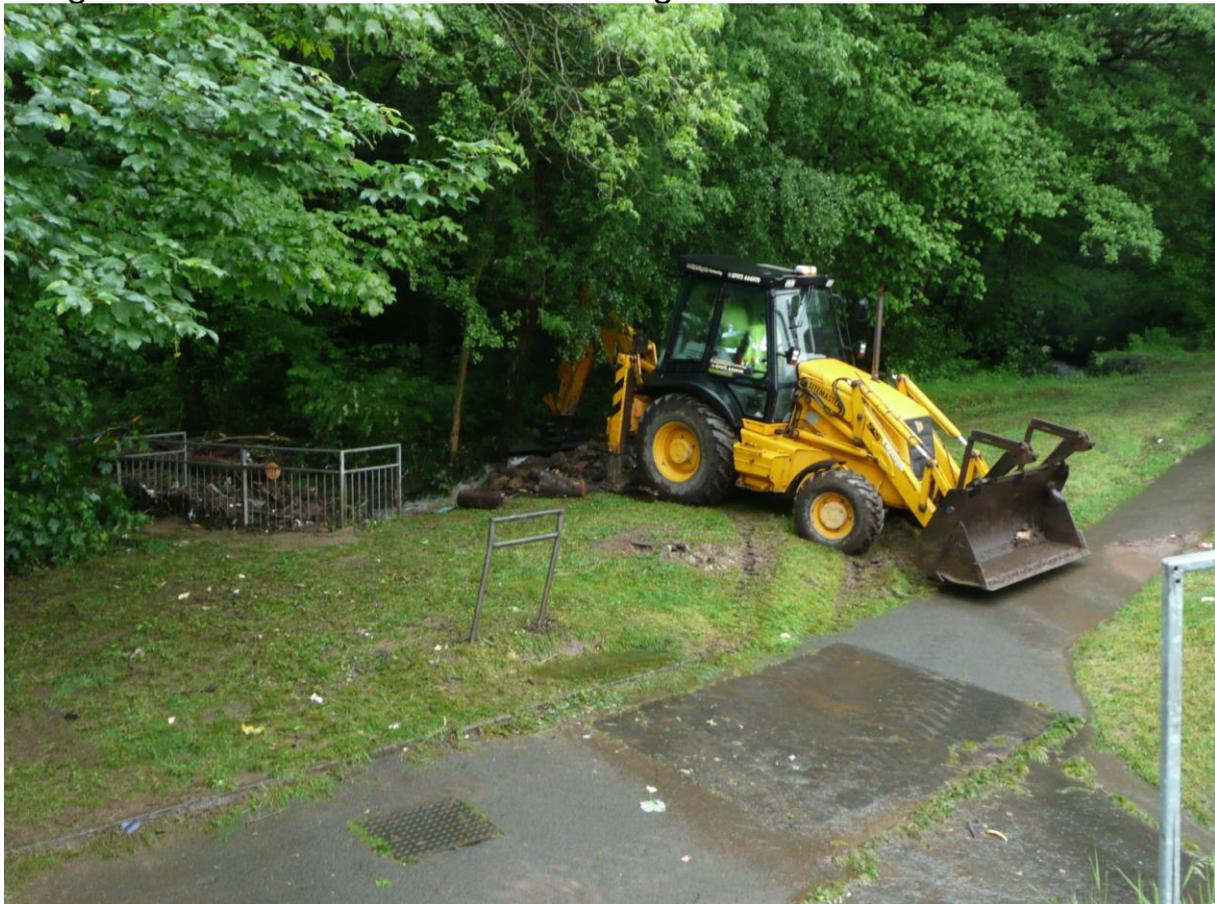
Image 7: Clean up crew on site at culvert 94 after the flooding

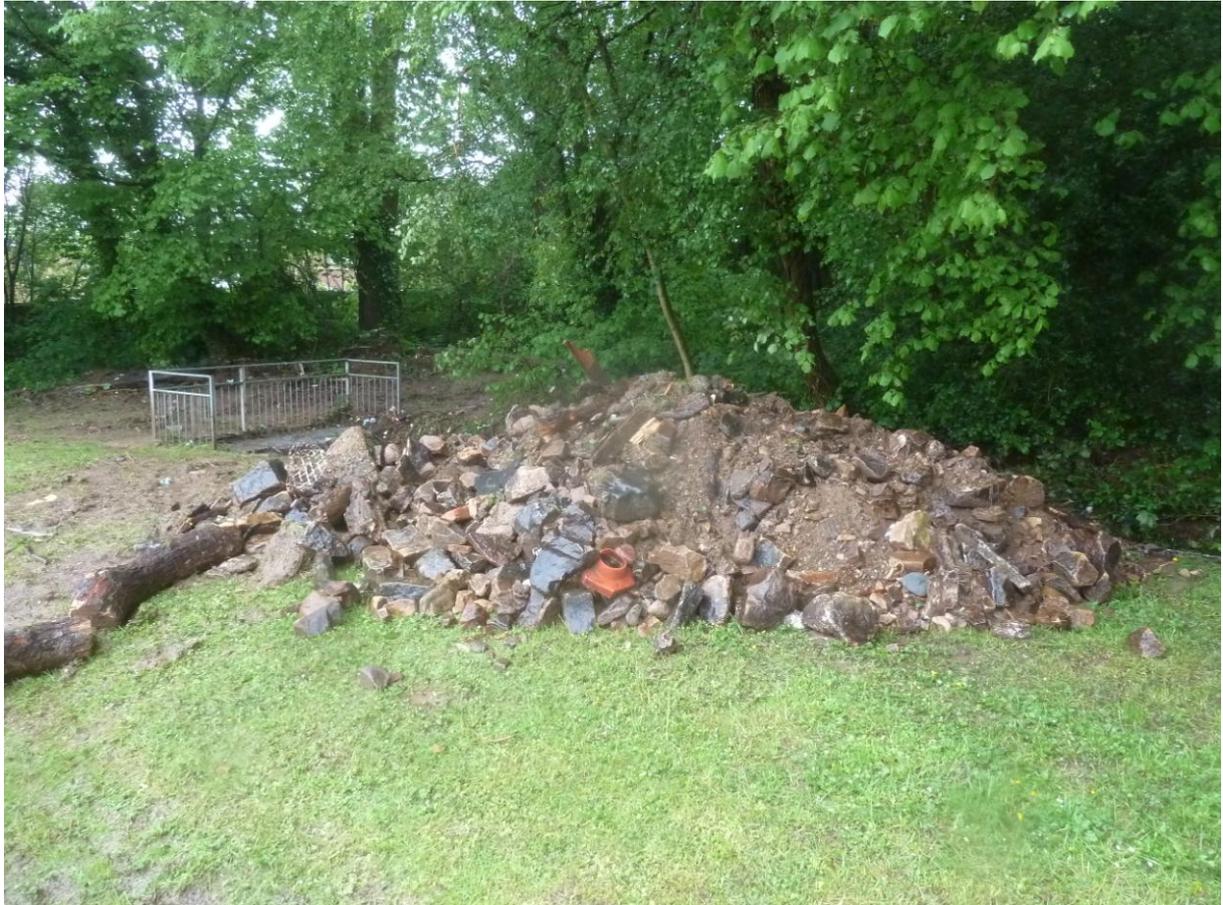
Image 8: Material removed from Culvert 94 totalled 35tonnes.

The teams did however begin closing sections of flooded highways to reduce the risk to the public and to contain the situation. The gully sucking crew was deployed until midnight cleaning gullies and drains throughout Cwmbran. The culvert crews were deployed through the day and over the weekend period ensuring the complete clearance of the culverts. The clearance was a prolonged operation due to the sheer volume of material brought down over the grills and guards. The total quantity of material removed has been weighed and totalled at 76.36tons. One culvert in particular (94) received a large amount of debris which totalled 35tons brought down over the grill.

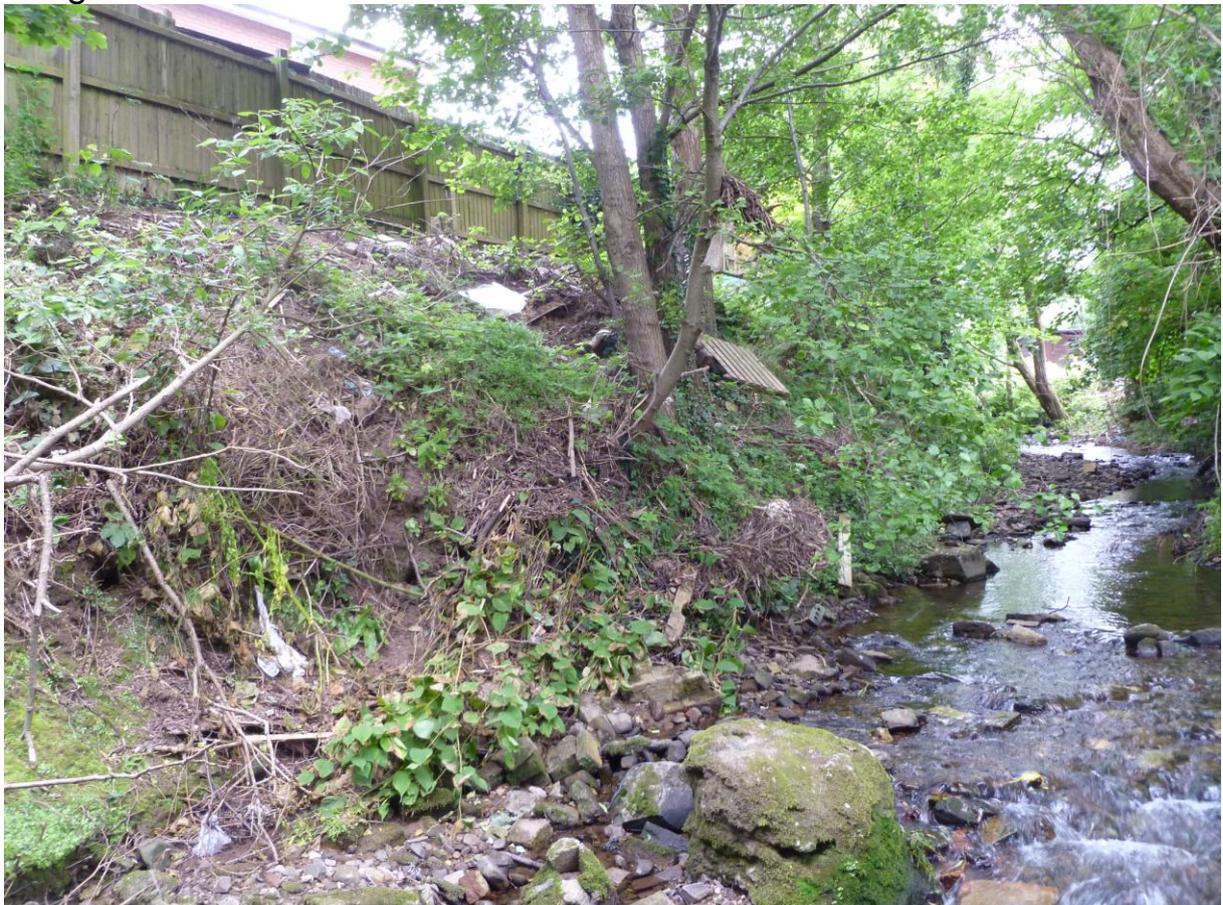
Image 9: The main river section of Dowlais Brook after the flooding event (above the inlet near Gifford Close).

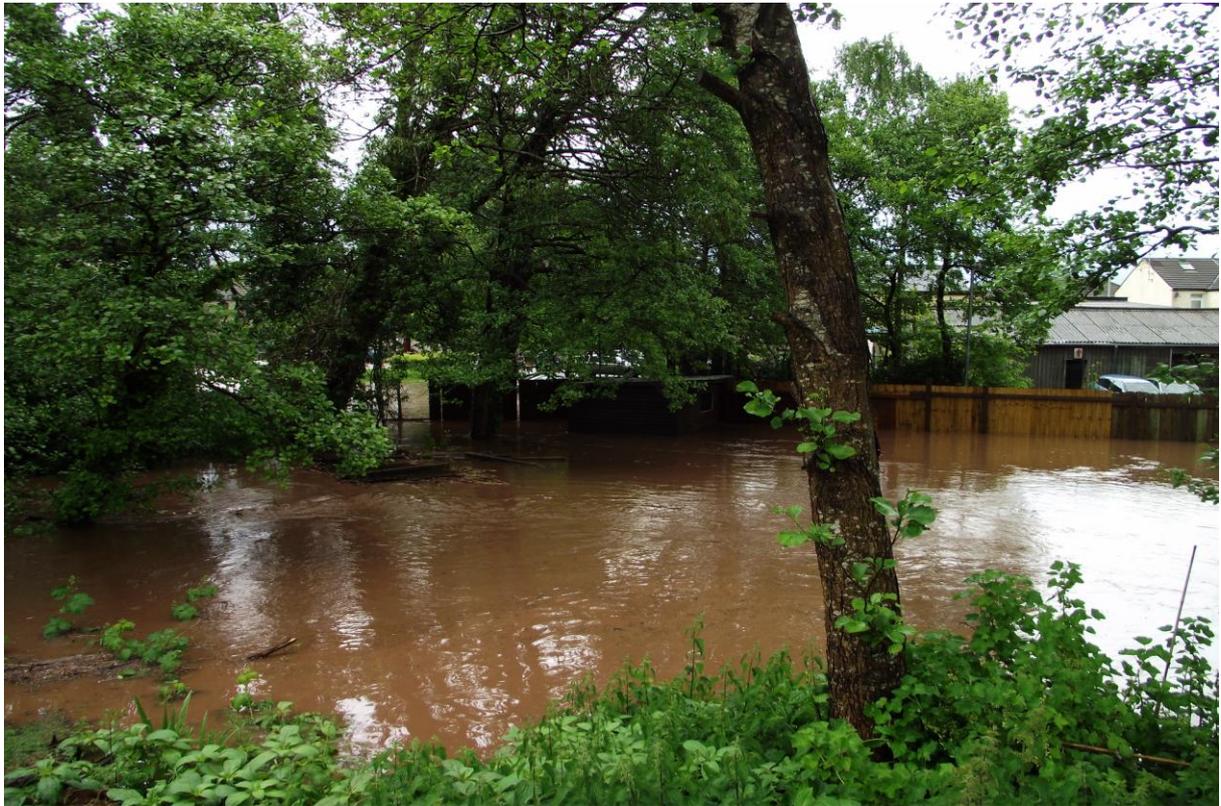
Image 10: The main river section of Dowlais Brook during the flooding event (taken from Gifford Close Bank).

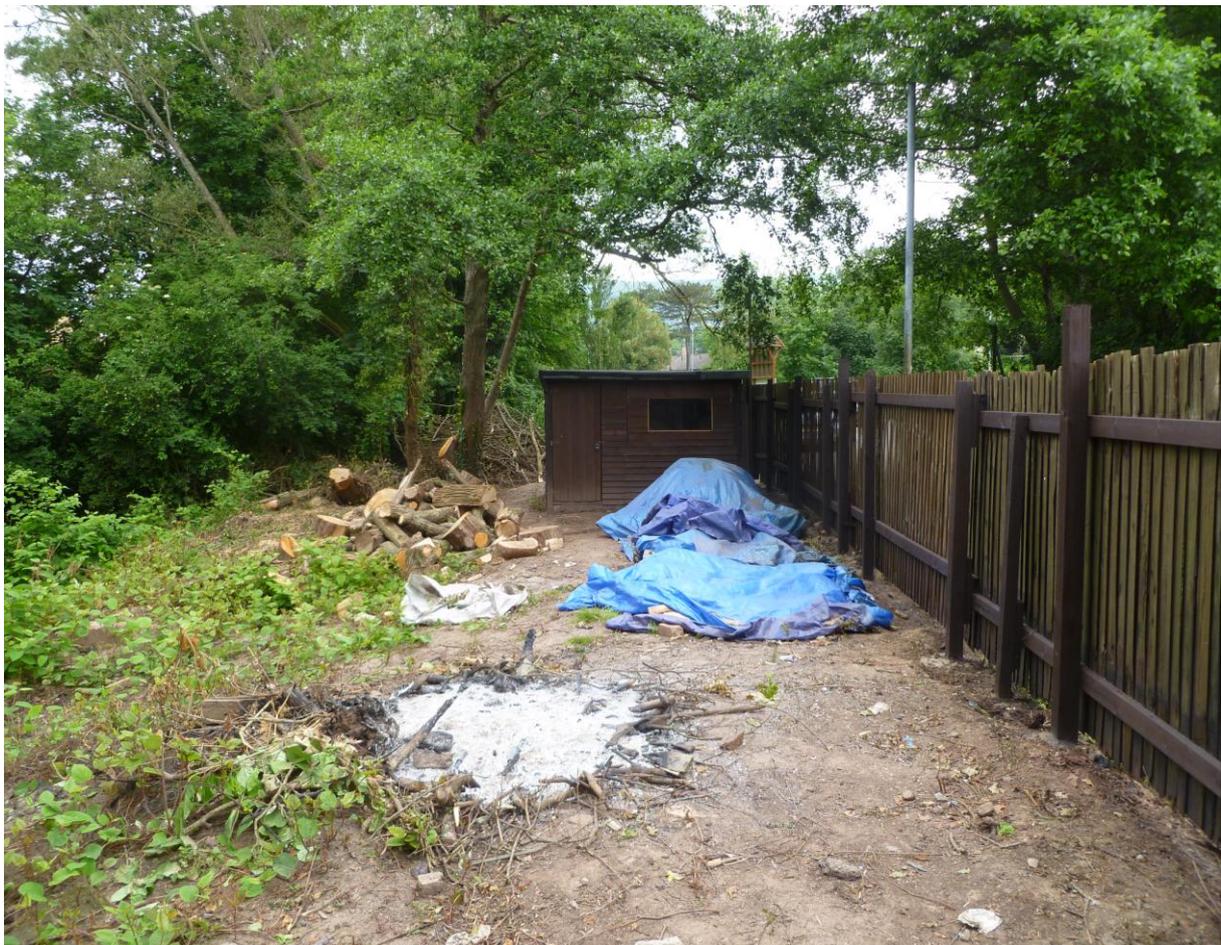
Image 11: Banks of Dowlais Brook above the inlet near Gifford Close (Privately owned and overseen by NRW).

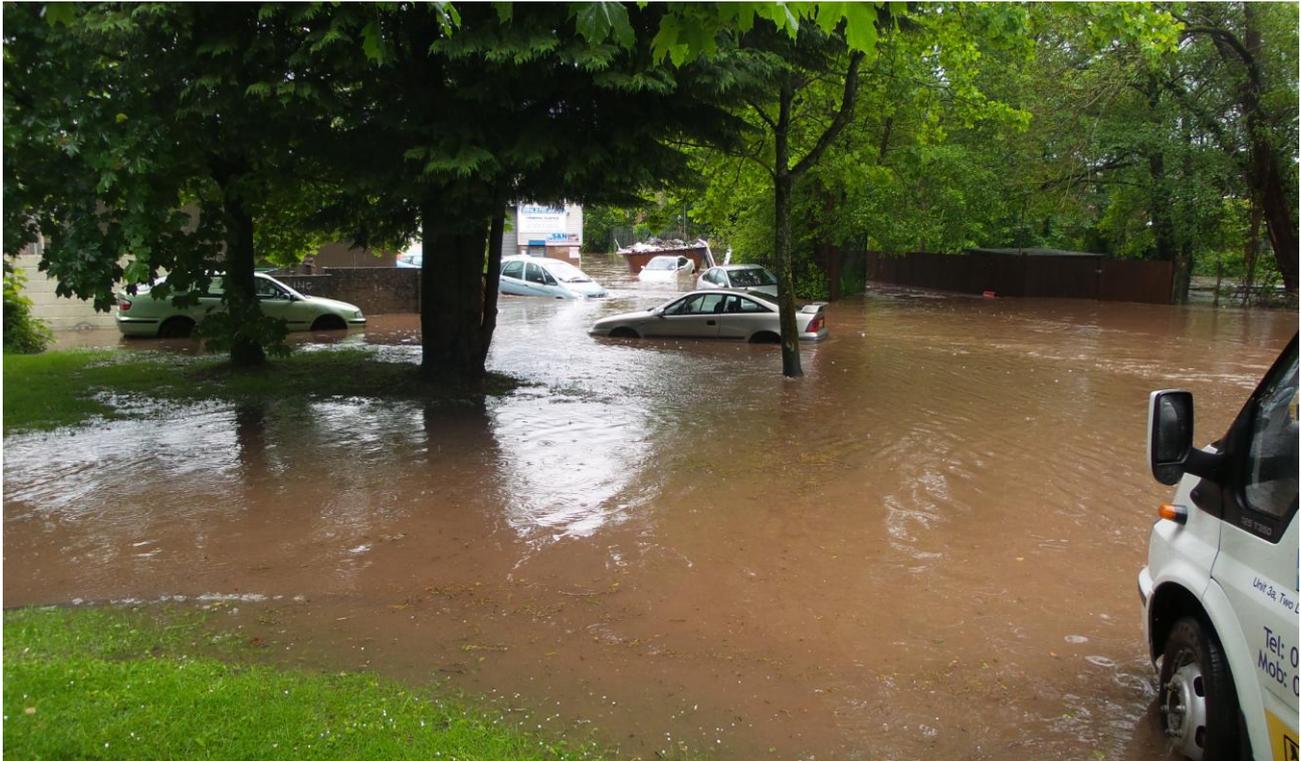
Image 12: Two Locks Road garage area next to Dowlais Brook.

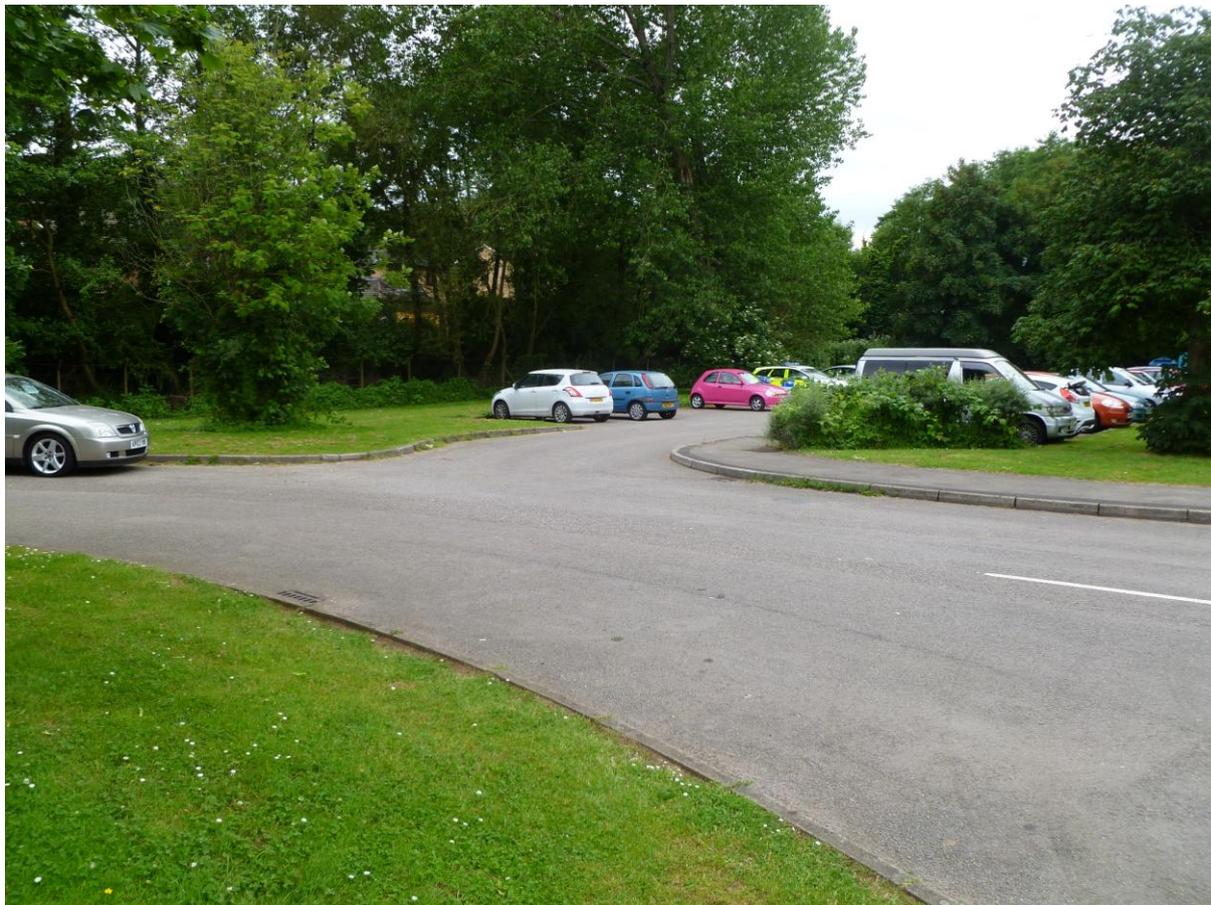
Image 14: Car park adjoining the Dowlais Brook, Two Locks Road after the event.

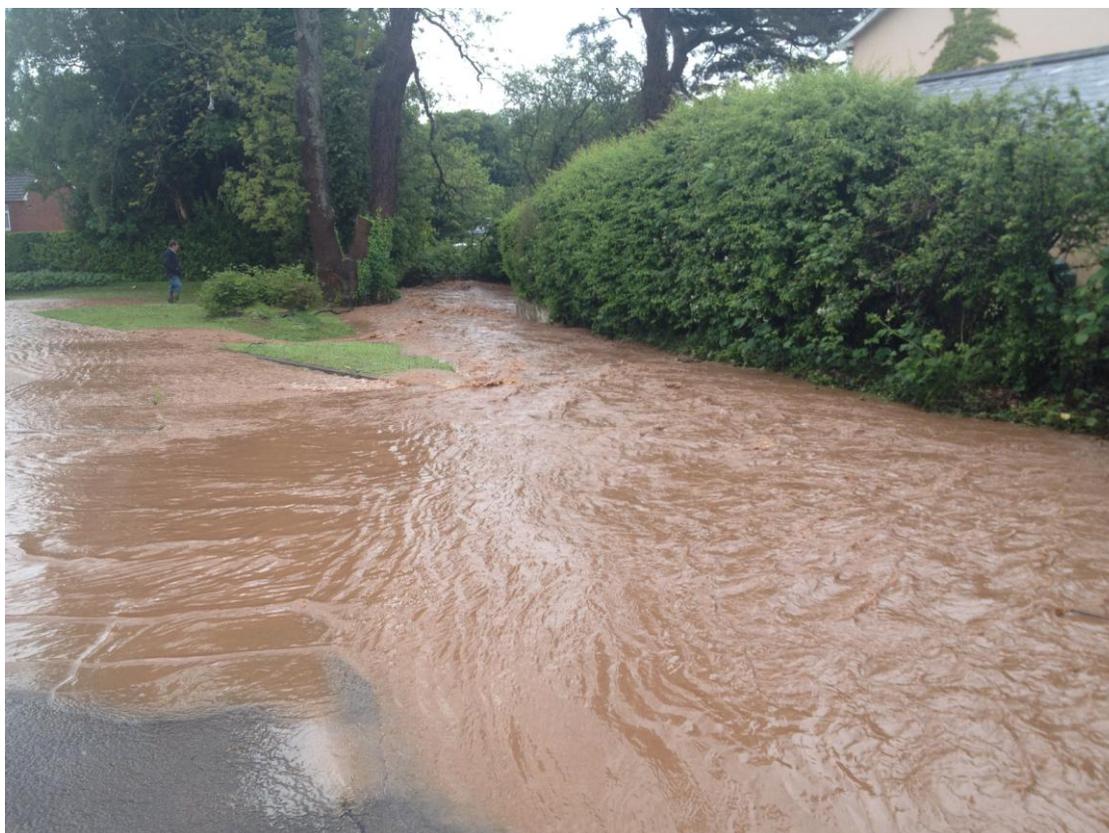
Image 15: Hollybush Close flood route after the rainfall event surcharging from Culvert 112

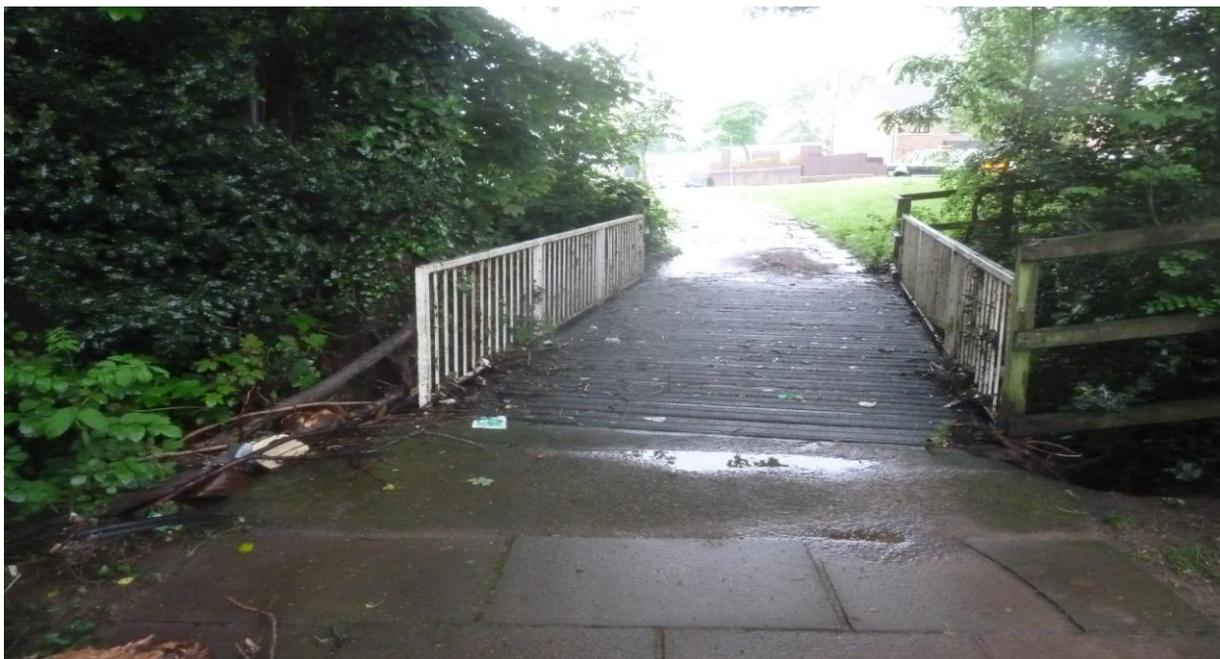
Image 16: Open footbridge that allowed the flow of water to travel across.

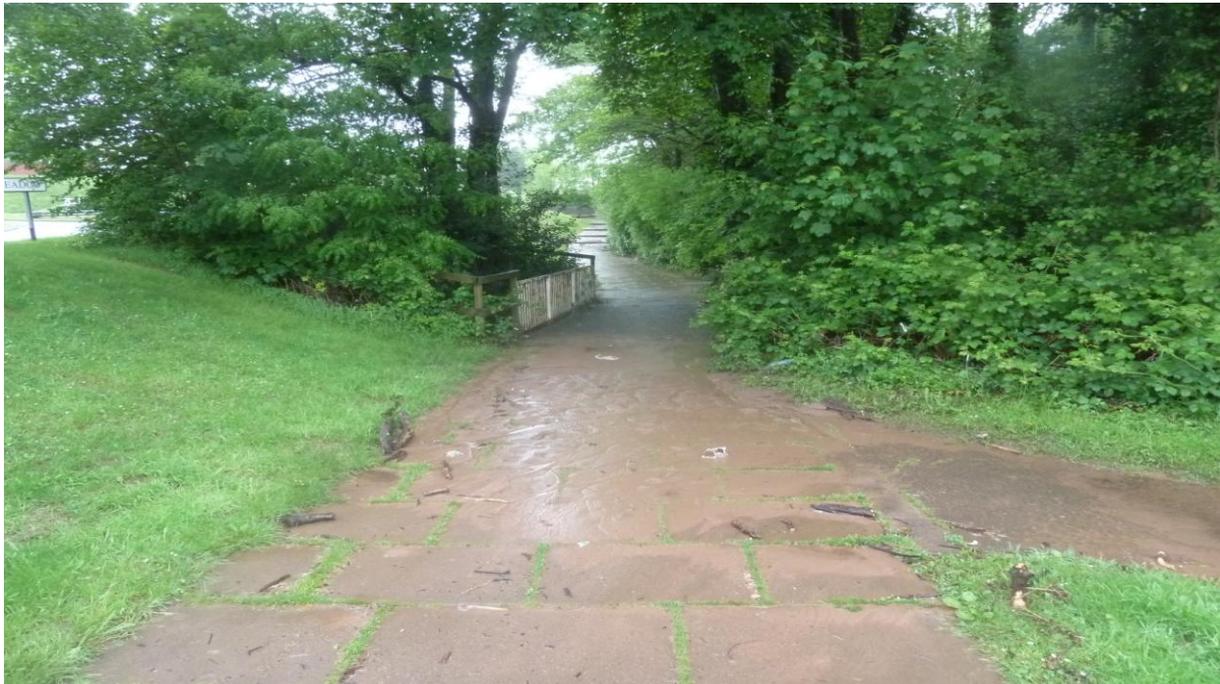
Several historical alleviation schemes are in place throughout the Cwmbran area, which include overflow channels along footways. These features were designed to direct the flow of an overtopped culvert and redirect it back into the watercourse. During this event these measures proved effective in the way that they channelled the flow back to the watercourse. However the sheer volume of water released into the system was enough to hydraulically overwhelm the escape routes and maintain a flow along the footways. In one case the flow was strong enough to pass across an open footbridge (Image 16) and continue onwards up an inclined path (Image 17) and down into several streets below.

Image 17: Inclined path uphill from the open footbridge.
